# **Description of the individual buildings**

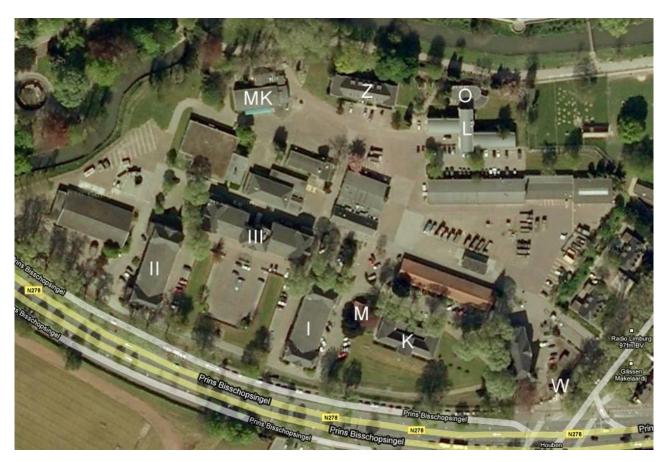
Aerial photograph showing the location of the major buildings

I = Barracks I, II = Barracks II, III= Barracks III

K= Soldiers' dining facility, L= Instruction building, M= Army depot, MK= former Dining facility, O= Officers' mess, W= Guard building, Z= Sickbay
